## Service Bulletin

**Title:** AIR CONDITIONING – Condenser Inlet Duct and Tail Rotor Drive Shaft Inspection.

**Summary:** This Service Bulletin requires immediate inspection of the tail rotor drive shaft below the condenser air inlet duct assembly before next flight.

**Effectivity:** Airbus Helicopter Deutschland GmbH (AHD) models MBB-BK 117 C-1 & C-2 with installed Air Comm Corporation air-conditioning system with the air ducts/fairing cutouts to the condenser.

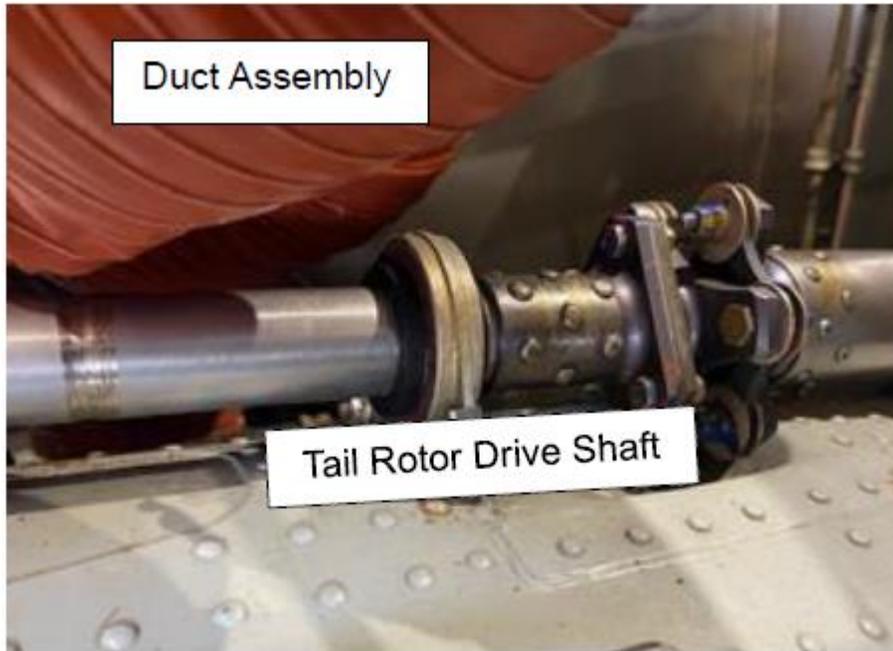
ACC has been made aware of multiple aircraft where excessive corrosion of the condenser inlet duct has allowed the internal support wire helix to break and protrude from the duct silicone shell and then impinging on the tail rotor drive shaft. In one instance, the tail rotor drive shaft was significantly compromised. It has also been noted on some installations that the duct support clamp was not aligned to the drawing representative position that would maximize the clearances.

Figure 3 – Typical Damage

2. Inspect the installation and condition of the ACC condenser air inlet duct assembly p/n EC145-7040-1.
  - a. Inspect the duct exterior condition. If any of the duct helix wire has broken and is protruding into or out of the silicone shell, then replace the duct assembly p/n EC145-7040-1 with a new assembly. Use the Figures in this document for the installation views, component orientation and required hardware.

- b. Inspect the duct interior condition and wire integrity. Minor surface corrosion of the wire helix is acceptable if it is less than 10% wire diameter and the silicone shell is not peeling or separating, otherwise, replace the duct assembly with a new one.

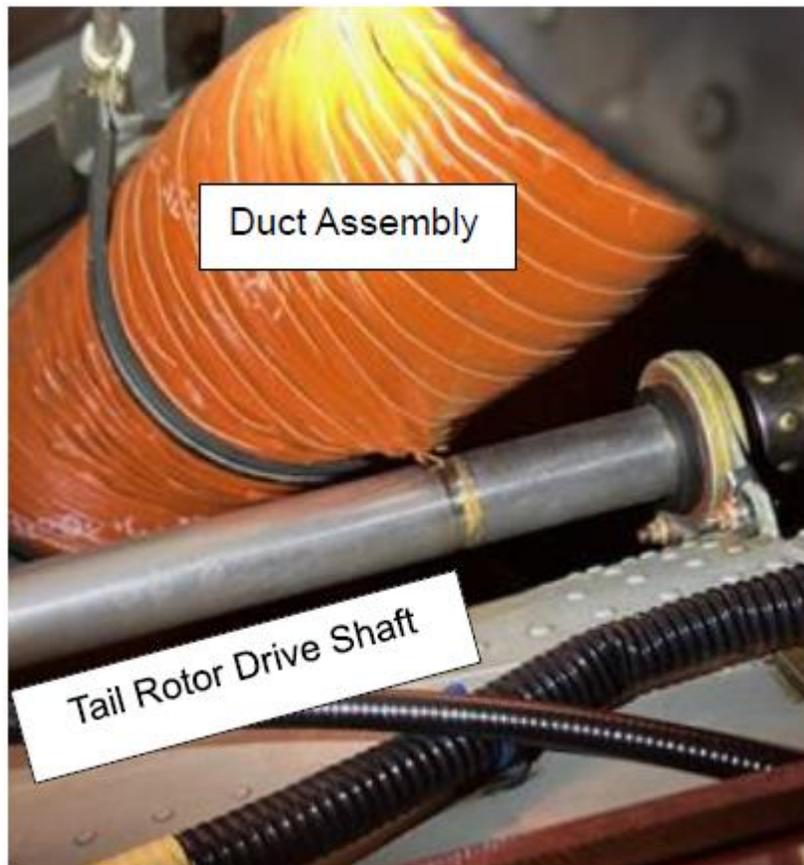
Figure 4 – Typical Damage with Low Positioned Clamp Shown

- c. Inspect the exterior clamp positioning. If it does not match the drawing Figures, in this document then rearrange the clamp to raise the duct positioning. Maintain a downward slope to the duct.
