Service Bulletin

Title: SB AS350-111014; Airbus AS350 Air Conditioner Aft Evaporator Wiring Harness Blower Motor Connector.

Date: July 6, 2016

Applicability: Airbus Helicopter model AS350 Equipped with the Air Comm Corporation AS350-202-1 thru -5 or AS350-204-1 thru -12 air conditioner system

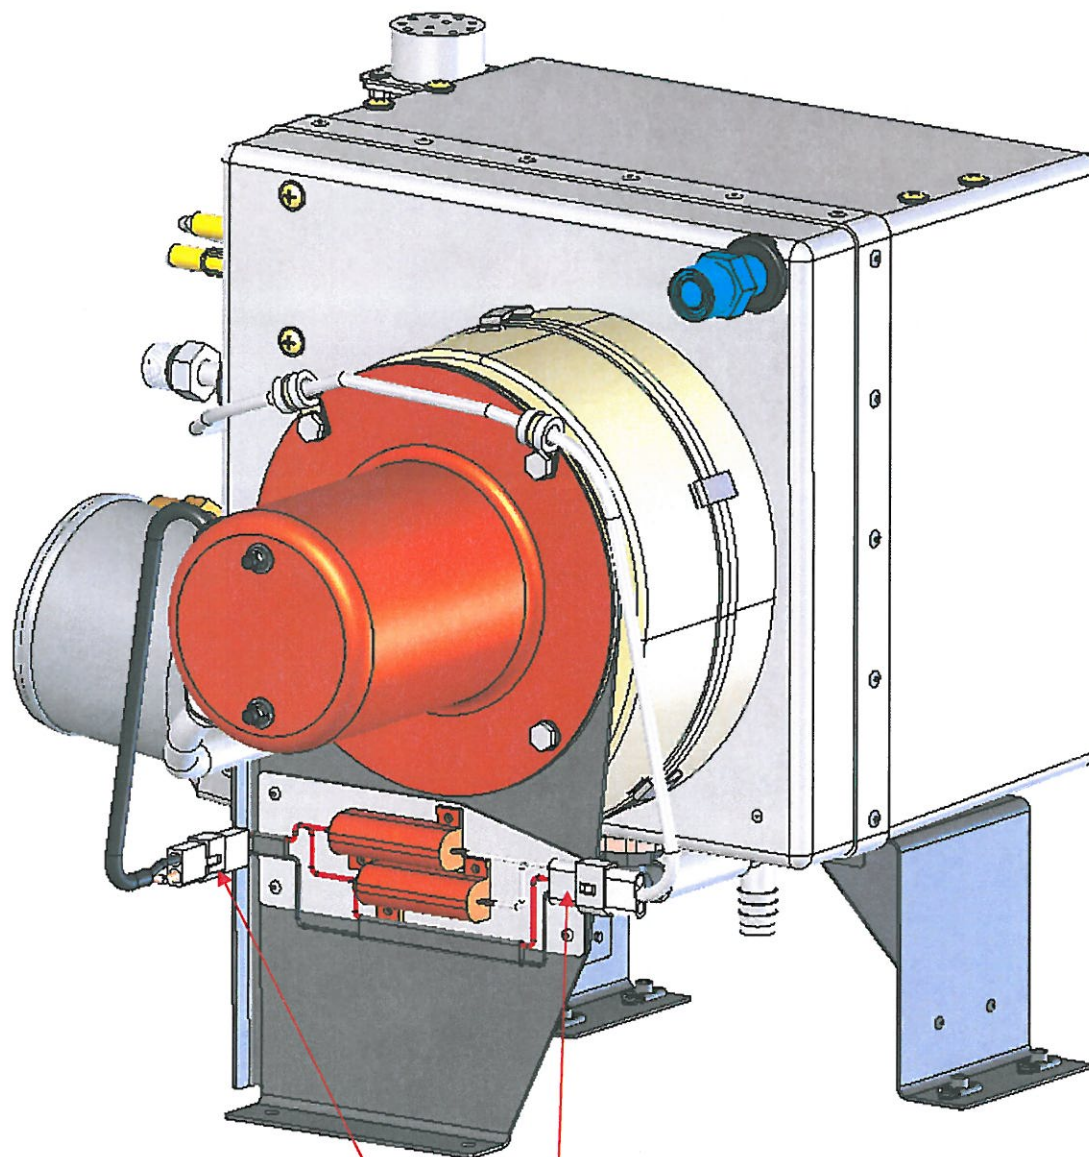
Figure 1 AS350-6202 Aft Evaporator Assy

Locate each connector as shown in Figure 1. De-mate each connector and inspect both mates for signs of overheating, discoloration or plastic deformation. Gently pull (estimated 5-7 lb of force) on each wire to verify the integrity of the contact's crimp. The contacts should be fully seated and locked in the housing so pulling gently on the wires will not dislodge the contacts from the housings.

Inspect these connector sets. If replacement is necessary, wire per Figures 2 thru 4

If any signs of overheating of the housing are present or if the pull test fails, the system must be rendered inoperative and the connector housings and contacts replaced with new replacement connectors using Deutsch HDT-48-00 Crimping tool or equivalent MIL-DTL22520 Type 1 crimping tool before further operation. See Section B for information on how to contact Air Comm.
