Service Bulletin

Title: SBEC135-25-02; EC135 Air Conditioner Condenser Wiring Harness

Blower Motor Connector

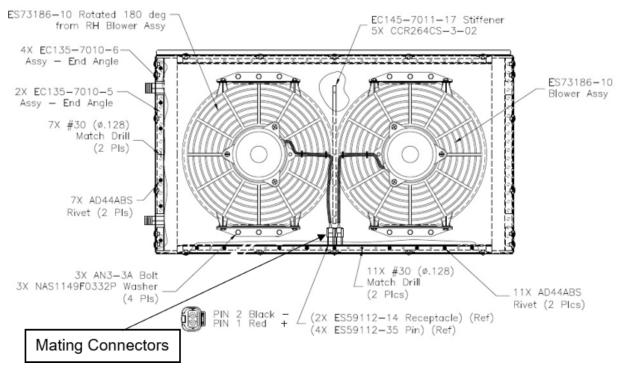
Figure 1: Condenser Assembly EC135-7000-2

The Molex motor connectors used in the Air Comm Corporation Condenser Assembly EC135-7000-1 and ES73186-9 are now obsolete and have been replaced with Deutsch connectors as built per EC135-7000-2 (shown in Figure 1) and ES73186-10 (Shown in Figure 2).

When replacing the top-level assembly P/N EC135-7000-1 with new P/N EC135-7000-2, it is necessary to replace both of the aircraft side connectors with new P/N ES59112-13. No further changes are then required.

If only performing a connector replacement due to connector failure, replace the obsolete Molex connectors on both blowers with the Deutsch connectors to convert the assembly from P/N EC135-7000-1 to P/N EC135-7000-2. The assembly must be part-marked accordingly.
